ASB EC135-64A-007

ALERT SERVICE BULLETIN

TAIL ROTOR - Tail rotor blade
Inspection of the drain hole alignment of the blade assy

Revision No.	Date of issue
Revision 0	2020-11-11

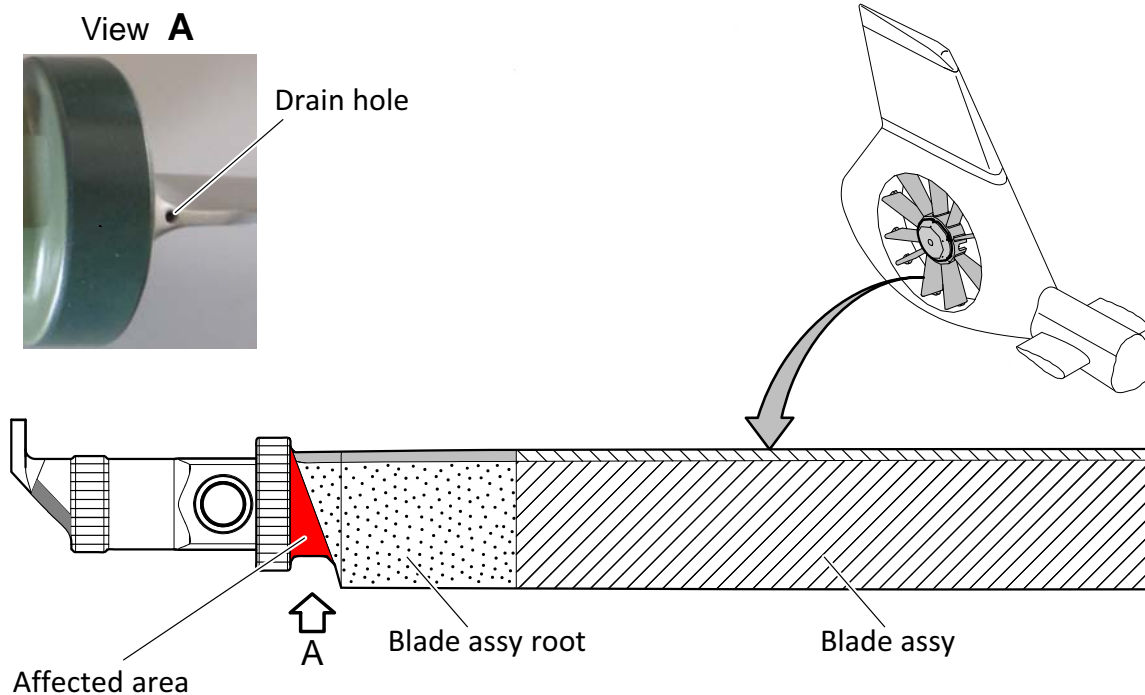
Location of the blade assy drain hole
Figure 1

This ASB introduces a one-time inspection for drain hole alignment of the Fenestron blade assembly. This ASB has been introduced following an airworthiness investigation on the EC130 and the requirement has been transferred to the EC135 based on the similarities in the production method. Additionally with this ASB, limits on repair details in AMM 64-22-00, 6-4 have been introduced (no further repairs are allowed in the affected area of the blade assy root).

NOTE Repair in the affected area of the blade assy root (Fig. 1) that was done prior to this ASB is examined with this ASB.

Repair in the affected area of the blade assy root (Fig. 1) in accordance with AMM 64-22-00, 6-4 is **not** permitted.

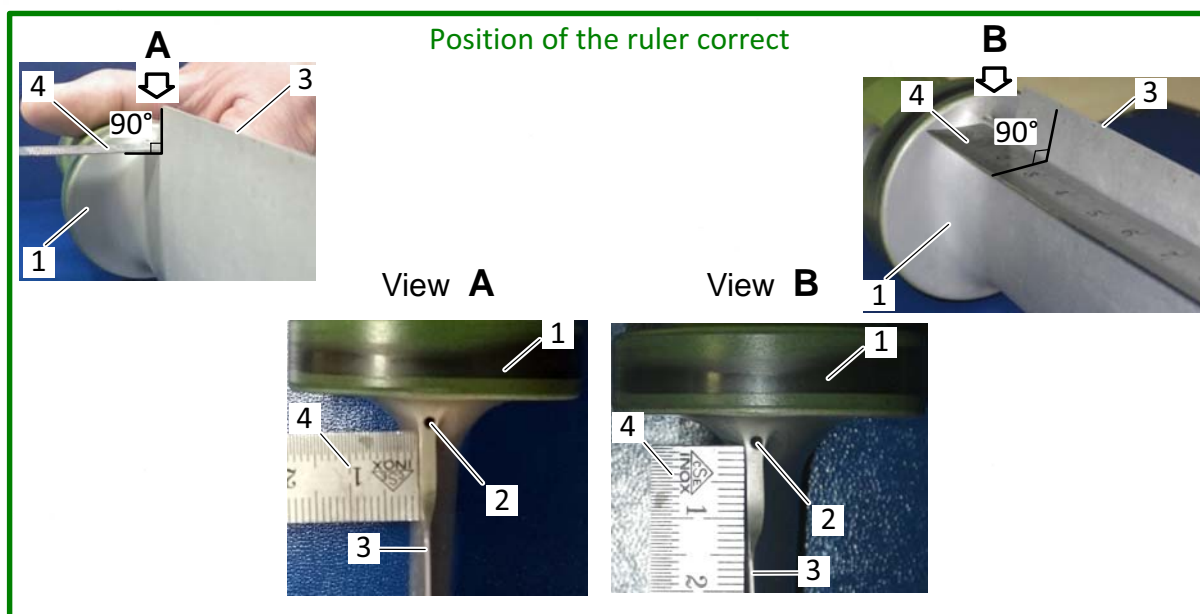
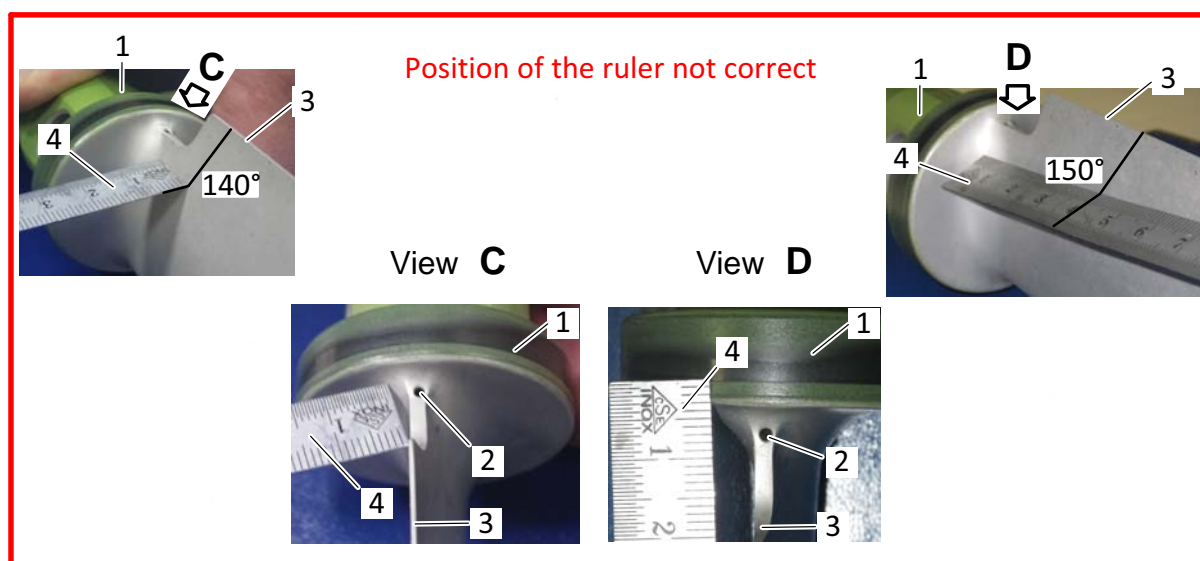
Position of the ruler
Figure 2

2. If required, move the yaw pedal (left or right) as required to expose the drain hole (2, Fig. 2).
3. Temporary mark the blade assys (1, Fig. 2) in the area of the drain hole (2) for identification (e.g. with numbers from one to ten or with the S/N of the blade assy (1)).
4. Position the ruler (4, Fig. 2) perpendicular and adjacent to the trailing edge (3) as shown in Figure 2.

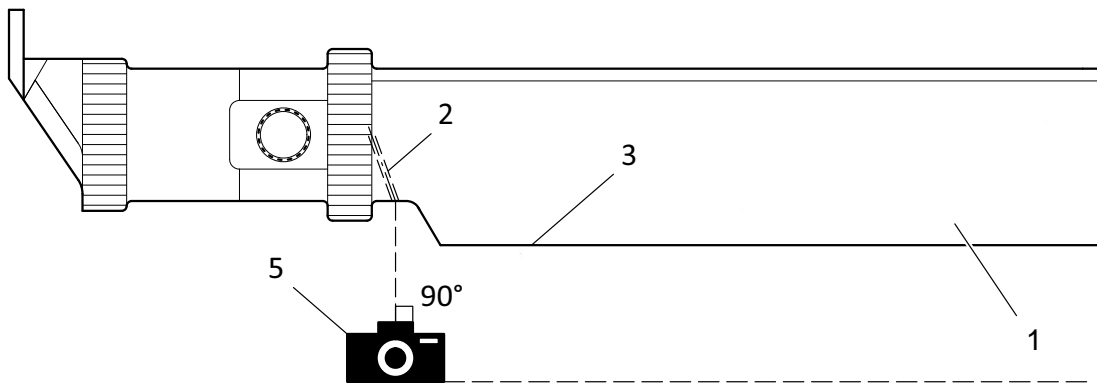
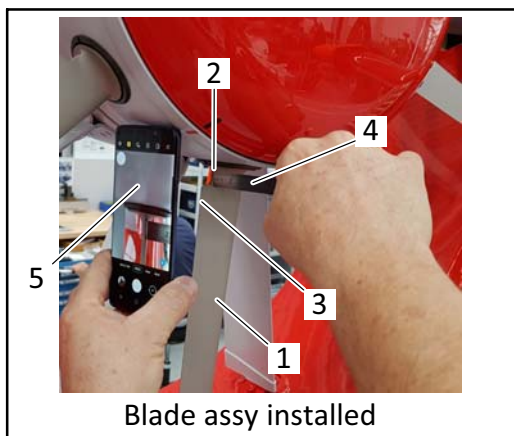
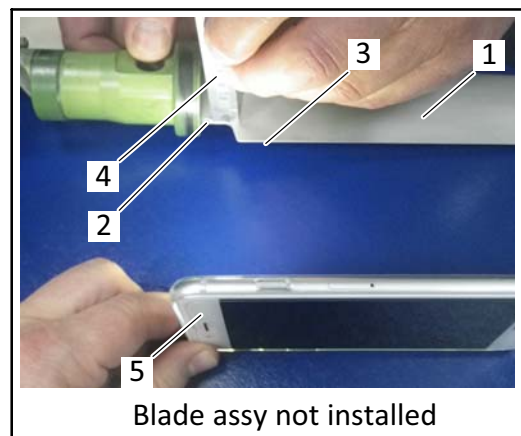
Recommended smartphone or digital camera position to take a picture
Figure 3

5. Position the smartphone or digital camera (5, Fig. 3) perpendicular to the drain hole (2) and parallel to the trailing edge (3) of the blade assy (1) as shown in Figure 3.

6. Take a picture of the drain hole (2, Fig. 3) of the blade assy (1).

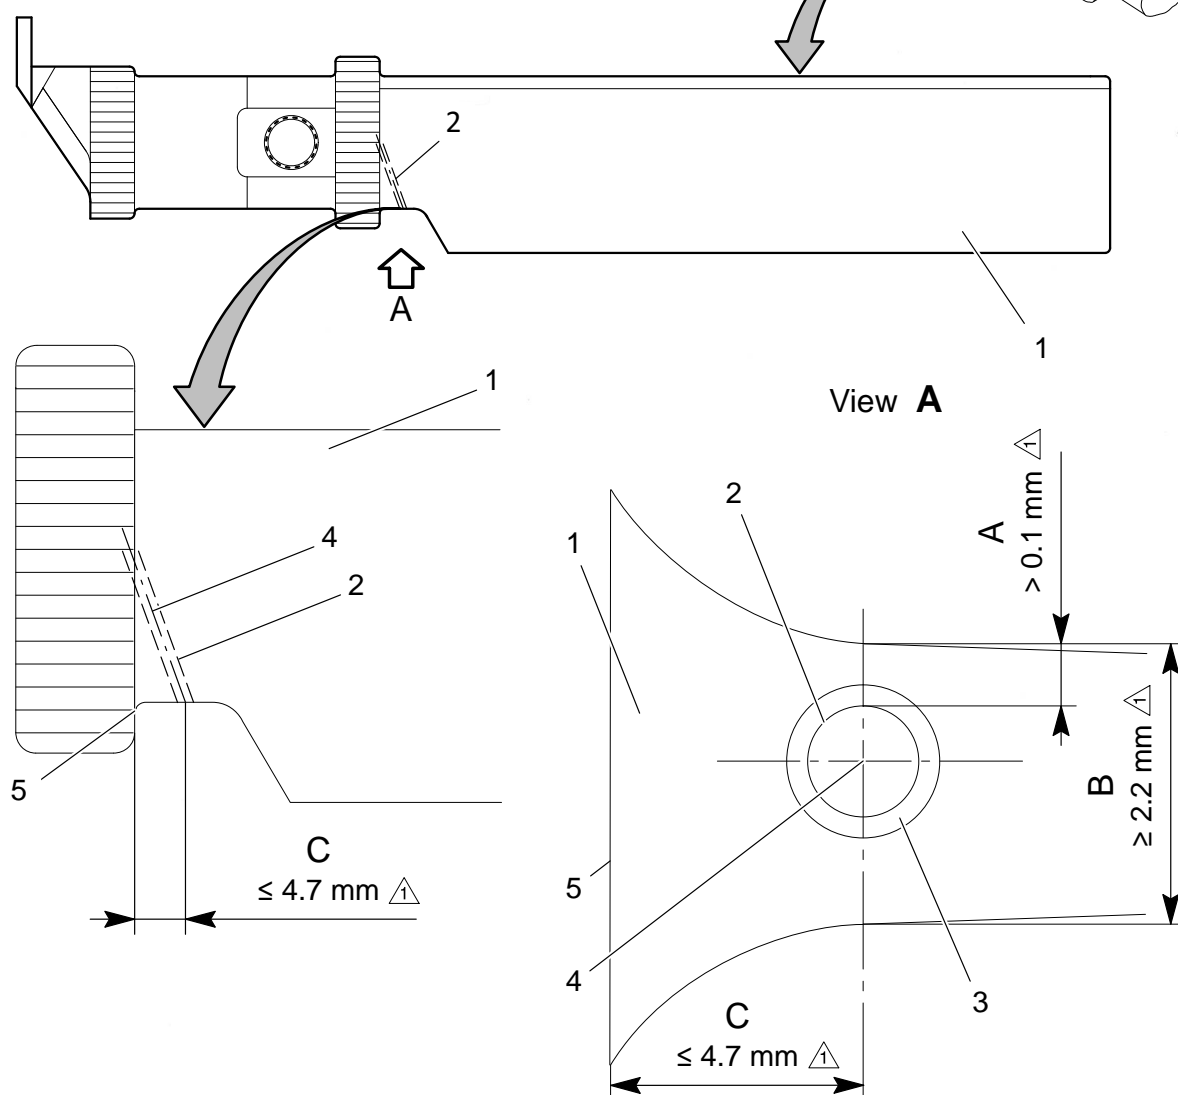
Inspection of the drain hole alignment of the blade assy
Figure 4

7. Measure the distance A, B and C and examine each individual blade assy:
 - a. Measure distance A, the minimum remaining rib thickness of the blade assy (1, Fig. 4), as shown in Figure 4.

Category A (compliant blade assy)	Category B (non-compliant blade assy)
Distance A is more than 0.1 mm.	Distance A is less than or equal to 0.1 mm.
and	or
Distance B is more than or equal to 2.2 mm.	Distance B is less than 2.2 mm.
and	or
Distance C is less than or equal to 4.7 mm.	Distance C is more than 4.7 mm.

1. If installed, remove the blade assy (1, Fig. 4) (AMM 64-22-00, 4-3).
2. Provide feedback to Airbus Helicopters.
 - a. With WebTEK access:
 - Create a TE on WebTEK: <https://keycopter.airbushelicopters.com>
 - Select the TE business domain: "ASB Fenestron Blade"
 - Insert the title: "ASB EC135-64A-007 Revision 0 - Blade assy category B"
 - Attach the picture of the blade assy (1, Fig. 4).
 - Send the TE.
 - b. Without WebTEK access:
 - Use the QR-Code:

3. Discard the blade assy (1, Fig. 4).
4. If removed, install a serviceable blade assy (1, Fig. 4) (AMM 64-22-00, 4-4).

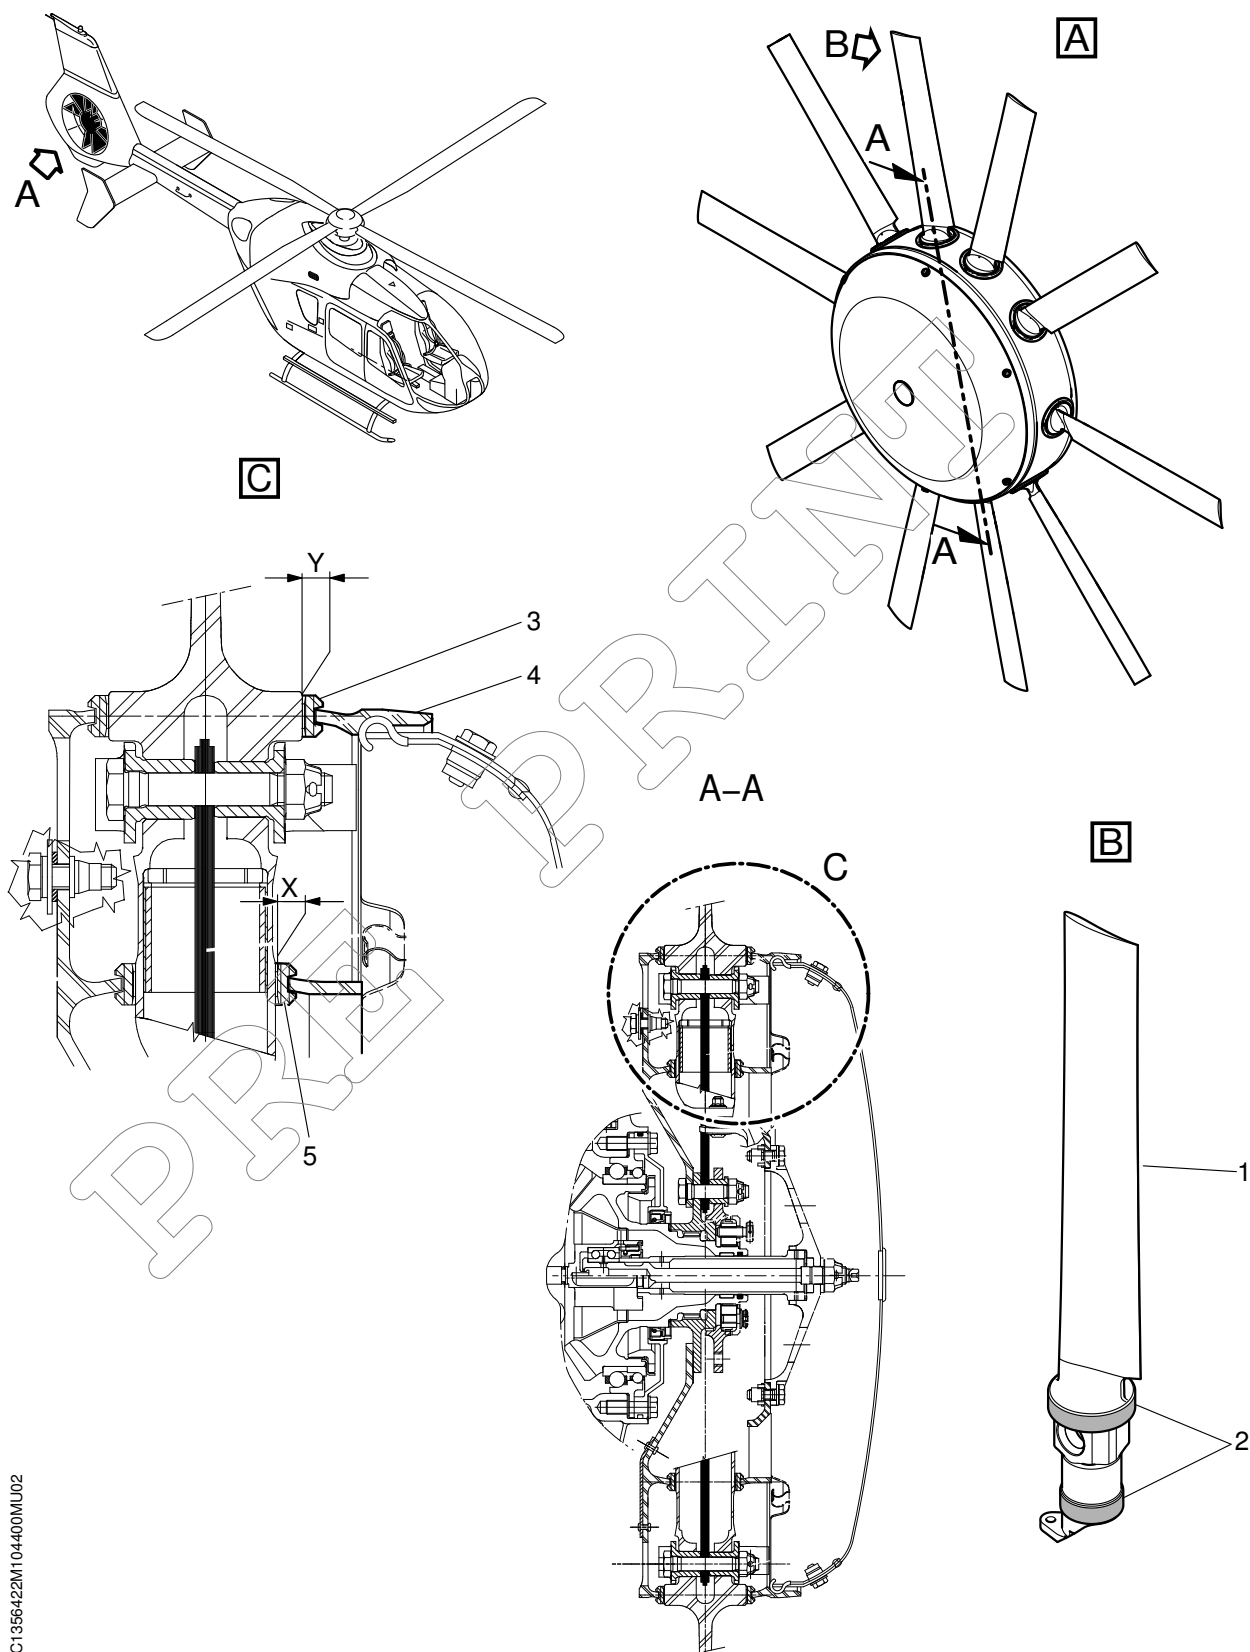
Inspection - Tail Rotor Blade
Figure 601

(1) Do the inspection of the *tail rotor blade* ^{CP} (1, Figure 601) as follows:

- Cracks
- Mechanical damage
- Corrosion
- Erosion
- Damage to the paint
- Wear of the black plasma layer on the bearing surfaces
- Correct installation of the balance weight bushing in the blade root (2).

limits (Table 601), replace the *tail rotor blade* ^{CP} (1) (64-22-00, 4-4).

- 2 If there is mechanical damage and/or corrosion within the damage and repair limits (Table 601), repair the *tail rotor blade* ^{CP} (1) (64-22-00, 8-1).
- 3 If you find erosion on the blade leading edge, measure the blade chord in the area of maximum erosion damage.
 - a If the measured blade chord is less than 48.5 mm (1.90 in), replace the *tail rotor blade* ^{CP} (1) (64-22-00, 4-4).

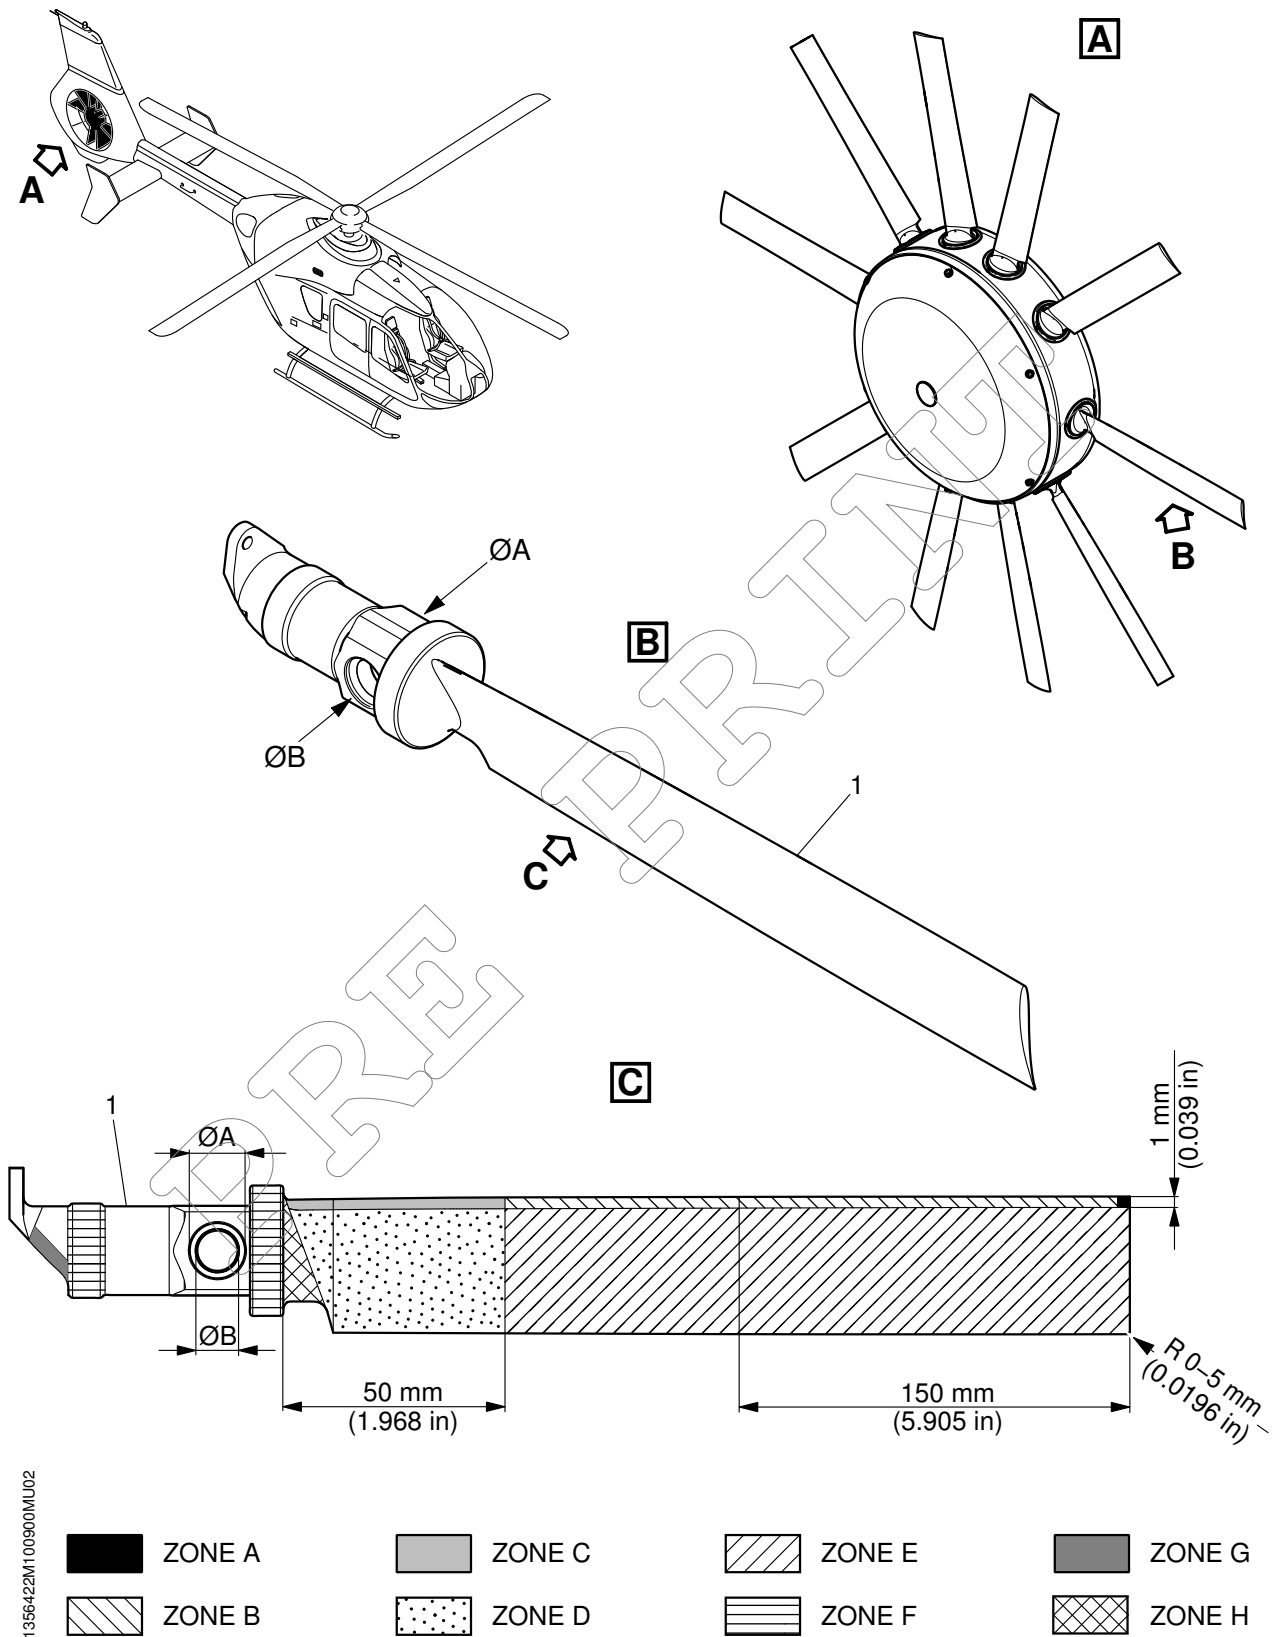
Inspection - Tail Rotor Blade
Figure 602

Zone (Figure 602)	Damage Limits (without repair)	Repair Limits (repair possible)
A	MAX radius of 2 mm (0.078 in)	MAX radius of 2 mm (0.078 in)
B	Dent with MAX depth of 0.45 mm (0.017 in)	Score with MAX depth of 0.45 mm (0.017 in) MIN residual blade chord of 48.5 mm (1.91 in) MAX length of 30 mm (1.181 in) in blade span direction
C	Dent with MAX depth of 0.45 mm (0.017 in)	Score with MAX depth of 0.45 mm (0.017 in) MIN residual blade chord of 48.5 mm (1.91 in)
D	Score with MAX depth of 0.01 mm (0.0003 in) Dent with MAX depth of 0.05 mm (0.001 in)	Score with MAX depth of 0.05 mm (0.001 in) MIN of 10 mm (0.394 in) in radius transition
E	Dent with MAX depth of 0.1 mm (0.0039 in) MAX of 0.5 mm (0.019 in) of diameter Score with MAX depth of 0.01 mm (0.0003 in)	Score with MAX depth of 0.15 mm (0.005 in) MIN distance of 2 mm (0.079 in) between scores Dent with MAX depth of 0.2 mm (0.007 in) and MIN of 2 mm (0.079 in) of distance between dents

Zone (Figure 602)	Damage Limits (without repair)	Repair Limits (repair possible)
H	For any anomalies found on the Upper and Lower surface, including the rib and the drain hole contact your local Airbus representative.	No repair is permitted
ØA	MAX diameter of 14.53 mm (0.572 in)	
ØB	MAX diameter of 13.53 mm (0.532 in)

(b) If the damage to the varnish in Zone F Figure 602 on the bearing races is outside the damage and repair limits (Table 601), apply Varnish CM 515 to the damaged area (20-00-00, 2-18).
